SUBJECT: LA-6 Model

DATE: March 1 , 1934

This Bulletin supplies detailed supplementary information to that issued in Machine Service Bulletins No. 161, Supplements A, B, C and D, and 165, 167 and 177.

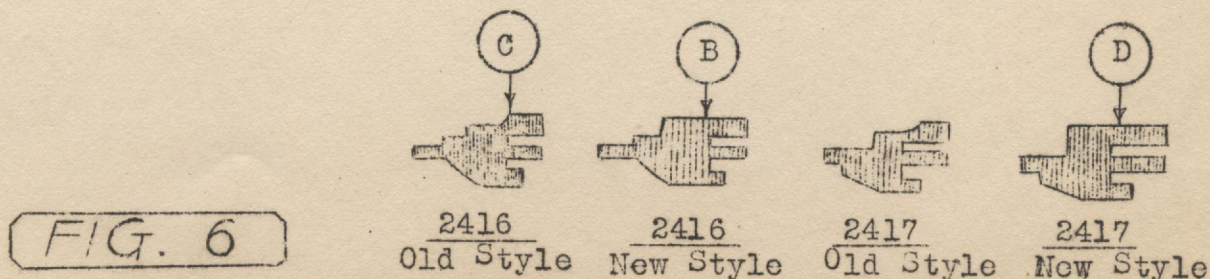
An improvement has been made in the carrying dogs by adding a small amount of stock on the top of the dogs at the points where they contact the feet of the wedges. See (B) and (D), Figure 6. In LA-6 models, due to the use of round tooth gears in the extra carry unit, it is necessary to set a slightly higher mesh between the dial gears and intermediate gears than in other L models. This higher mesh causes the wedges (A) to be depressed slightly later by the carrying pins than with the deep mesh, and we have found that this delay, even though it is slight, causes the wedges, when they are depressed, to strike the top of the dogs rather than to drop in front of them. In order to overcome this condition, we have added a small amount of metal to the top of the dogs so that the delay in depressing the wedge is compensated.

Figure 3 illustrates the correct engagement of wedges (A) with the new style 2416 dogs (B).

Figure 4 shows the incorrect condition caused by the wedges (A) dropping late and riding on top of the 2416 old style dogs (C).

Figure 5 illustrates the correct engagement of the wedges (A) with the new style 2417 dogs (D).

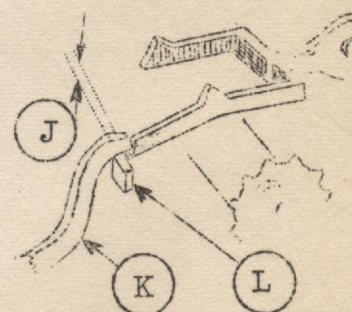
FIG. 21

Adjust blank (F) so that when dial (B) is at zero and slide (E) is unlatched, (D) will clear pin (C) by approximately  $1/32$ ". When clearance exists at (J) and (E) is latched upward, turn dial (B) to zero and raise the carriage. See That the automatic left hand side mechanism is set to neutral.

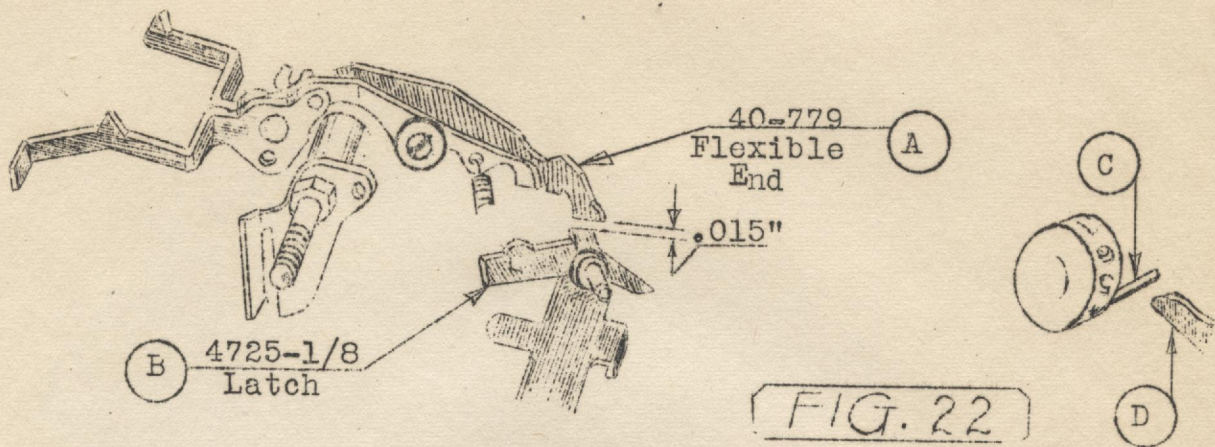
With the carriage in operating position note that when pin (C) settles on the end of (D) the flexible end (A) of the trip lever is raised more than enough to unlatch (B). This excess movement of (A) should be approximately .015.

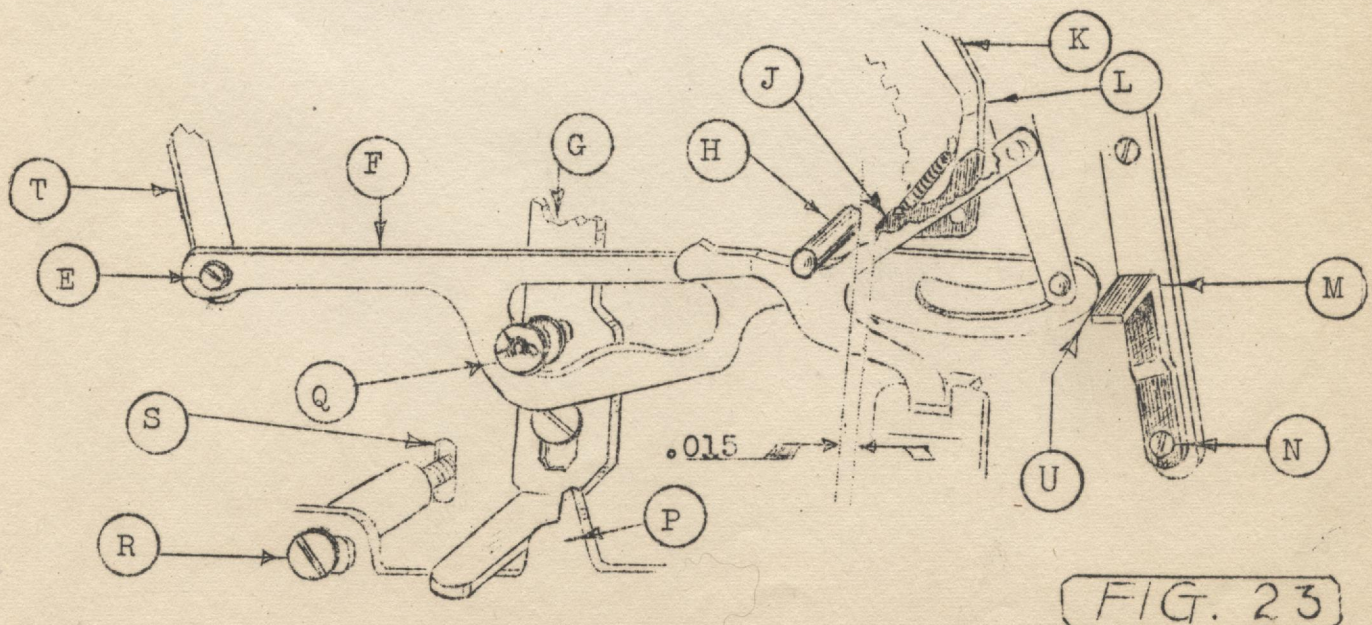
When the multiplier slide (G) is unlatched from (P), pin (H) should clear (J) by approximately .015. When the multiplier slide (G) is latched on (P) and the machine turned backwards, pin (H), upon engaging the end of (J), should trip the automatic mechanism so that the machine will not make a complete reverse cycle. When the machine is turned forward, pin (H) engages latch (J) causing it to yield and no tripping of the automatic mechanism occurs. To adjust (J) to (H) bend (K) at (L).

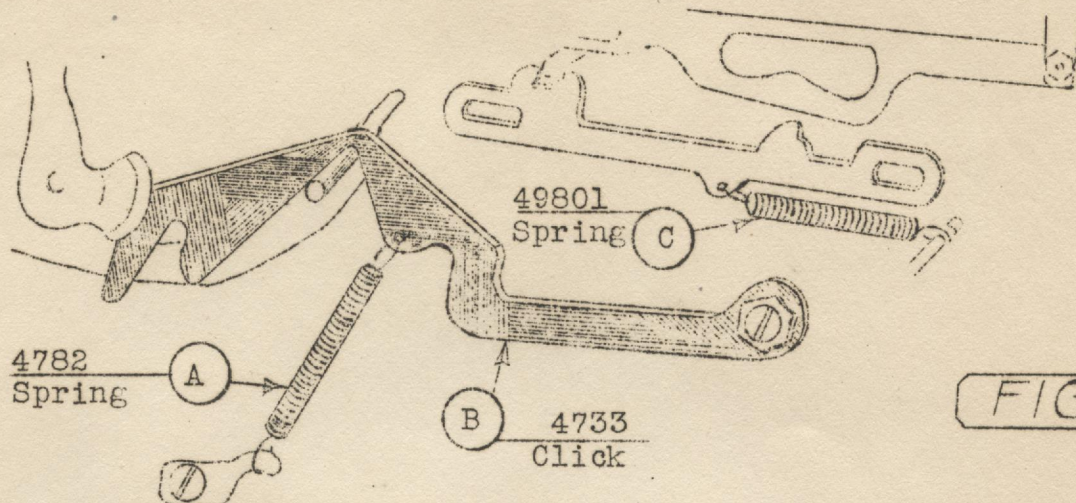
FIG. 26

A good adjustment of the clutch yoke trip arm (E) with stud (D) is important.

The new style division lever click (B) should be installed in all machines. (See Machine Service Bulletin No. 161-B, Plate 28.) Upon installing the new click it is important that spring (A), 4782, is of standard length and tension. Therefore, if the original spring has been shortened, replace it. It is also necessary to replace (C), 49801, with a 788 spring.

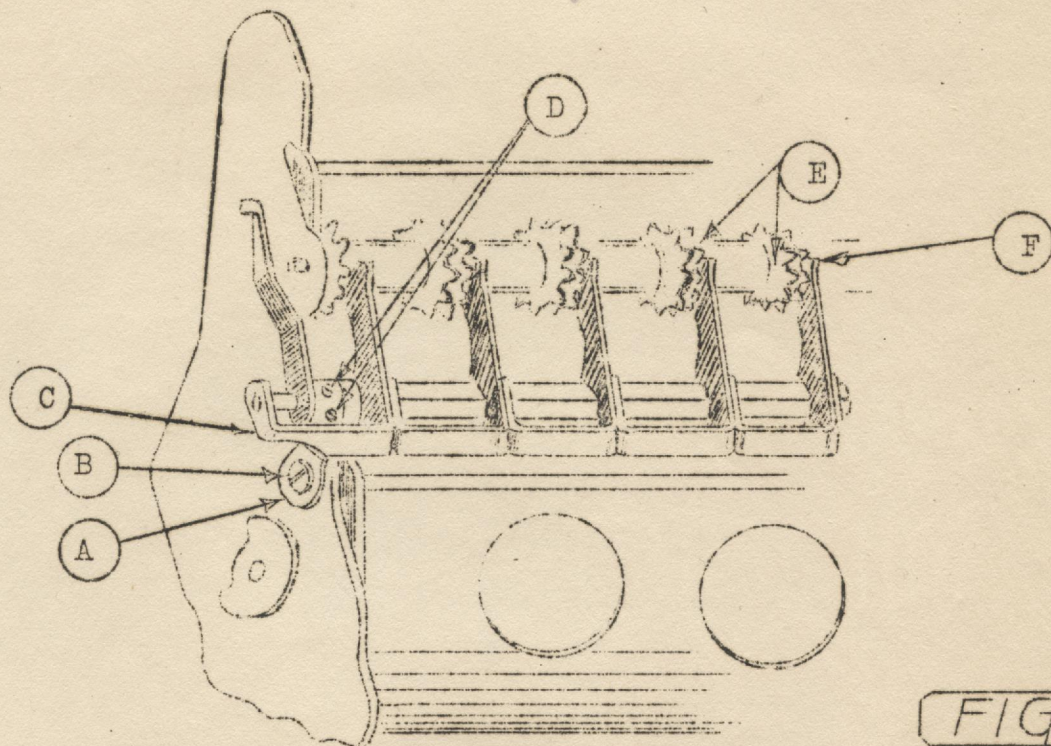
FIG. 29

If at the end of subtraction in automatic division, or at the end of the forward correction cycle, the machine should continue to run, trip levers (F) are adjusted too low.

If in automatic division, the machine should reverse itself before the division is complete in a column, the trip levers (F) are adjusted too high.

The points of trip levers (F) should extend slightly below the surface of the teeth on gears (E). Holding the points at this position, loosen (B) and place blank (A) up against the fold of arm (C) and tighten screw (B) securely. Loosen screws (D) and position arms (F) upward or downward in relation to the regular trip lever. After the desired adjustment has been made tighten screws (D) securely.
